Product Service Bulletin

Vol. 3, December 2002

Current Trends Bearing Down On Electrical Stress Can Protect A Motor

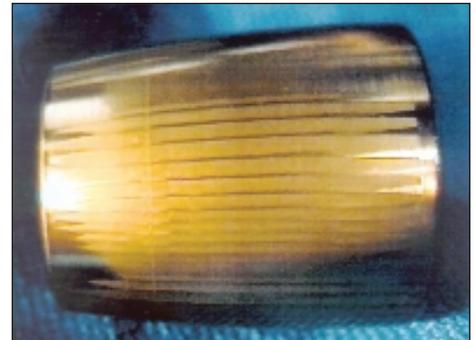
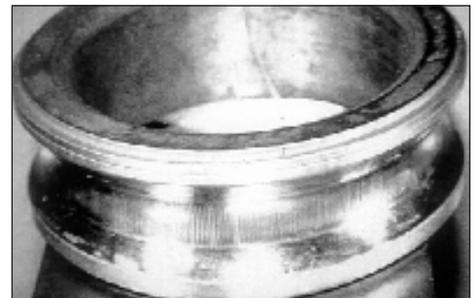
Fluting due to shaft currents on both a roller bearing, above, and a ball bearing, below.

Indications of shaft voltages include "fluting" or a "picket-fence" signature on the race of the bearing. Fluting due

to shaft currents can occur on both a roller bearing and a ball bearing. The spacing of the fluting marks depends on the rpm, diameter, radial load and magnitude of the shaft voltage. In some cases, the appearance of the balls offers the best clue. Instead of a highly-polished finish, the rolling elements may have a dull grey or smoky appearance.

US Motors suggests using a protective ceramic coating on the bearings when the bearings indicate shaft currents are present and have caused the failure. This approach may not be practical on smaller size motors, however, some bearing manufacturers do offer an anti-friction bearing with an insulated outer race or rolling element.

EASA shops receiving a US Motors brand motor for repair are encouraged to re-coat the materials before installing new bearings, if the ceramic was damaged. Keep in mind that when insulating a bearing housing, you must also insulate the face of the bearing cap. The bearing cap could come into contact with the face of the bearing, bypassing any insulation on the bearing housing.

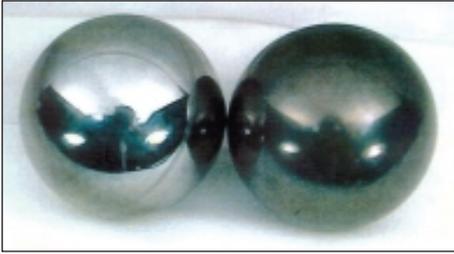
When rotational speed varies, the shaft currents may cause a dull, frosted appearance instead of fluting.

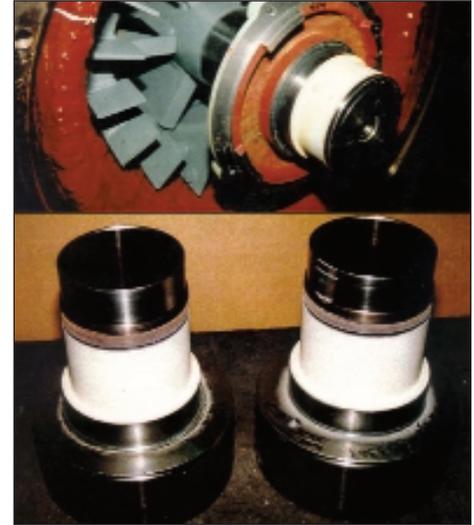
Ceramic or aluminum oxide spray is one method of insulating. Above, an opposite drive end bearing journal, and below, vertical motor bearing carriers, all of which have been insulated with ceramic spray.

The practice at US Motors is to insulate the non-drive end shaft bearing journal with a ceramic (aluminum oxide) coating. Insulated sleeve bearings are purchased with the outer diameter insulated by the bearing manufacturer. Insulated bearings are provided as a standard feature on all US Motors products in the 5800 through 9600 frame series, all Titan 6 pole motors, Titan sleeve bearings motors and Titan

Be sure to take special care when applying the ceramic coating because ceramic chips easily. Care should also be taken when balancing a shaft with ceramic-coated journals because the layer of ceramic is relatively thin. The rotor weight should not be placed on the journals for balancing or inspection because the point-loading is likely to break the ceramic loose from the shaft. The damage does not show up until the motor is in service, at which time the ceramic fractures, leaving the bearing with a loose shaft fit.
