Product Service Bulletin

Vol. 1, October 2002

Tips to Identifying and Preventing Overloads and Environmental Contamination

EMERSON
Motor Technologies

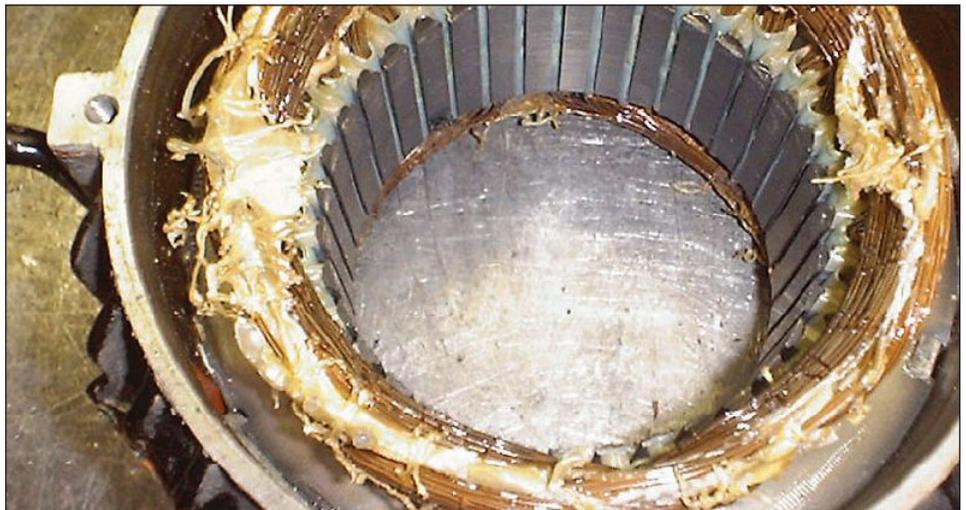
Popped strings and melted phase paper indicate overload.

Another common cause of motor failure is overloading. When investigating a potentially overloaded motor, the following questions will yield important clues: What are the three-phase full load amps and voltages? Has the application on the motor changed since its original installation? Was the motor sized properly?

An overloaded motor will have a general burnt appearance in the winding (see photo). A winding failure resulting from a defect in the motor, which is warrantable, will be more localized in nature.

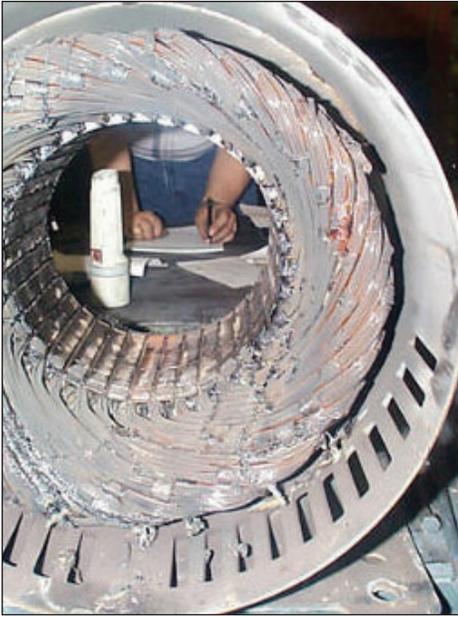
Generally discolored winding of an overloaded motor.

Overload can occur when the driven load is larger than the motor is capable of handling or if insufficient voltage is applied

at the motor terminals. A motor that does not have proper ventilation and overheats is a form of overload. It is difficult to distinguish between the causes for a "roasted" winding, i.e., overload, low voltage, or ventilation, since the results are similar. Emerson requires that the ambient air temperature used for cooling the motor not exceed the rated ambient on the nameplate, typically 40 C (104 F). If the motor is operated in an enclosed or restricted area, a sufficient quantity of cooling air must be supplied as determined by Emerson with a maximum temperature of 40 C (104 F).

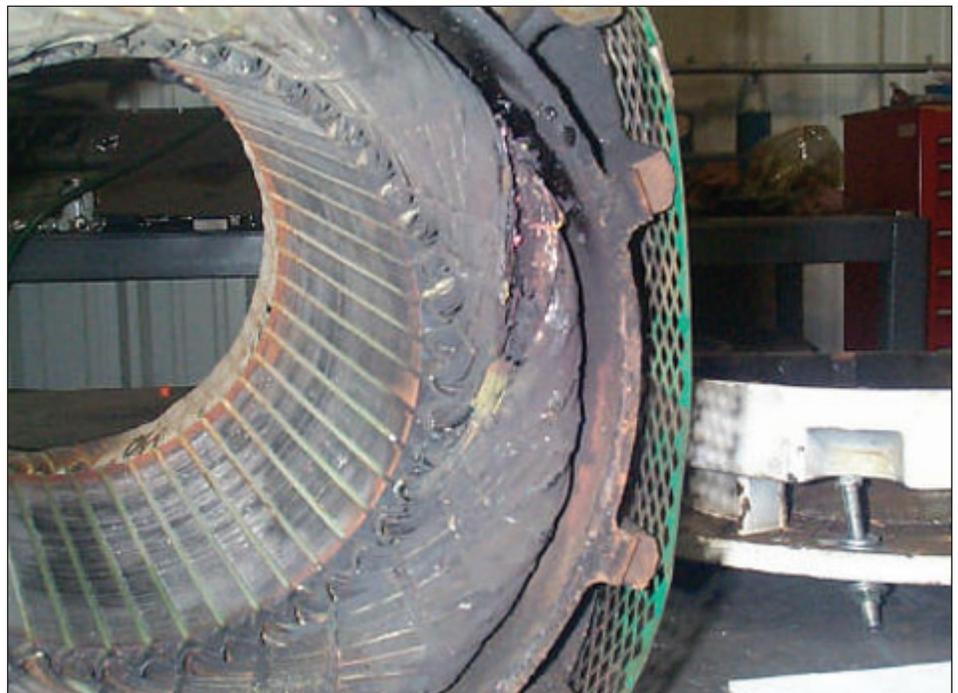
One common cause of motor failure is water damage within a motor (see image). This can often be identified by the presence of rust, telltale water lines and green specs

(copper oxides) on the winding. A low megger reading can also indicate water contamination.

Rust from moisture contamination

Emerson motors are constructed for both indoor and outdoor use. If the motors are going to be used outdoors, they may be subject to humidity and moist environments. Some basic precautions are recommended when installing an Emerson motor outdoors that will help prevent moisture damage, such as using a space heater or trickle

voltage heating. Heaters will keep the winding above the dew point and prevent moisture from collecting on the winding and other internal parts. Enclosed motors, by the nature of their construction, help prevent these contaminants from entering the motor. Large open motors may utilize an available filter accessory to control the ingress of contaminants.
