Product Service Bulletin

Vol. 2, November 2002

Belt Watch Identifying Improper Belting Applications Early Can Save A Motor

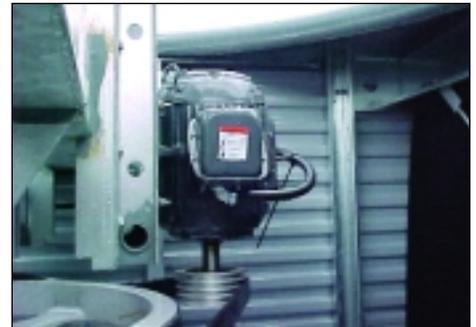
Motor sheave mounted on end of shaft and beyond center point of sheave. Motor shaft eventually snapped.

- Are the sheaves in the approximate ratio or are they obviously mismatched?
- Is the motor sheave out on the end of the shaft or is it next the shaft shoulder?
- Do the sheaves have grooves cut into them?
- Are the belts drooping or are they tight as a guitar string?
- Is the belt guard full of belt dust?
- Are the belts cracked and stiff?
- Is the system vibrating excessively?

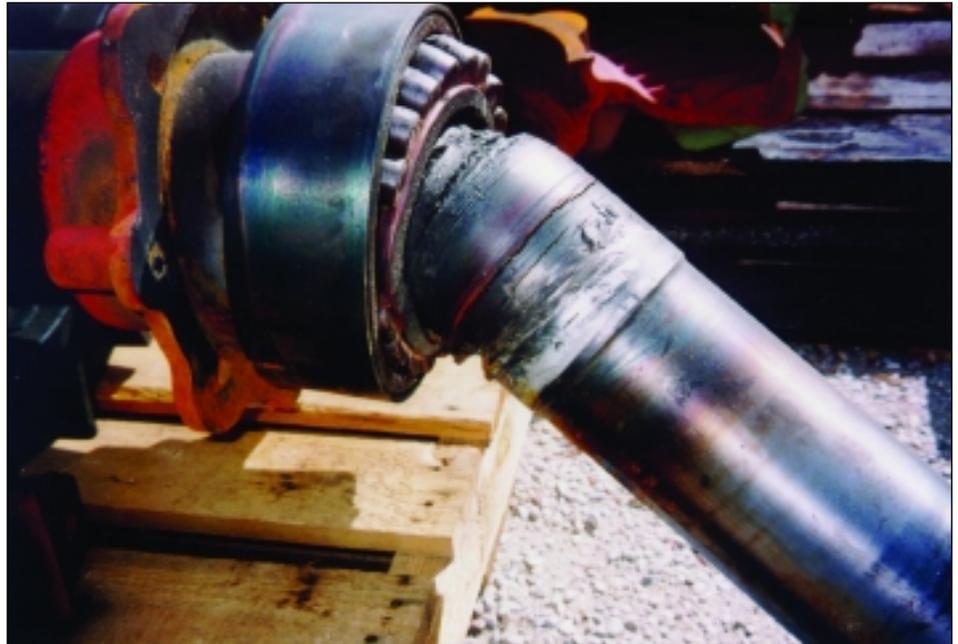
Motor failed due to mismatched and over-tightened sheaves causing excessive heat and melting motor shaft.

excessive a broken shaft can result. Proper alignment of sheaves is very important in preventing failure. If not properly aligned, the belts will wear incorrectly, causing excessive vibration, broken belts, bearing failure, etc. Correct sheave diameter ratios are a must. Getting the incorrect ratio of drive sheave to driven sheave can result in not enough belt contact with the sheave allowing the belts to slip. Mounting a sheave at the end of the shaft will not only turn the shaft into a lever, dramatically increasing the chance of breaking the shaft, but it also increases the load on the bearing.
